Manhole Inspection Summary

Manhole # S59E__001MH

Insp Date: **1/9/09 9:00 AM**

Location Address: **51 KRESSON-I 895-ALLEY**

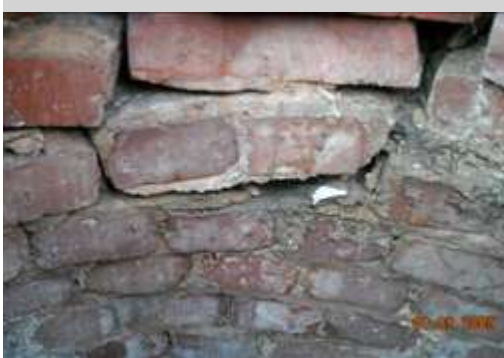
Defect 4

☒ **Cracked**

CRACKED CORBEL BRICKS

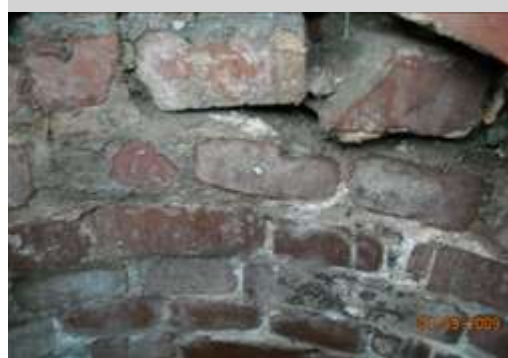
Defect 3

☒ **Loose Brick**

LOOSE CORBEL BRICKS

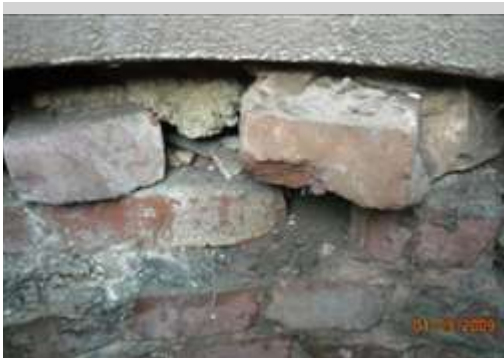
Defect 2

☒ **Cracked**

CRACKED CHIMNEY BRICKS

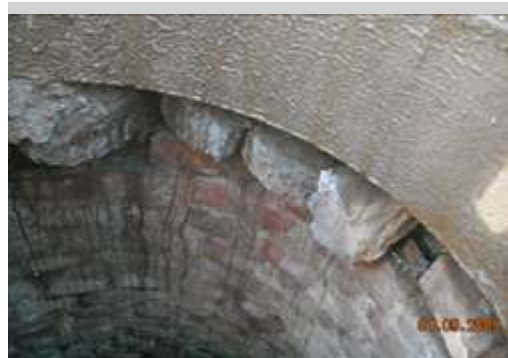
Defect 1

☒ **Leaks**

☒ **Loose Brick**

FRAME LEAKS, LOOSE CHIMNEY BRICKS

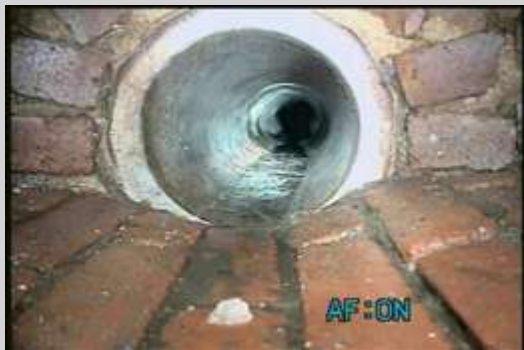
12 O'Clock Outflow

8 in. Circular Gravity Sewer
Pipe Out @ 12 O'Clock

Pipe Height: **8.4** (in.) Rod and Bar (Angled)
Pipe Material: **Clay** ☐ Pipe Lined
Invert Depth: **7.75** (ft.) Flow Characteristics: **Slow**
Deposits: ☒ None ☐ Mud ☐ Sludge ☐ Debris ☐ Grease
Silt Depth: **0** (in.) Deposits Extent:
Infiltration: **None** Pipe Seal Cond: **Sound**

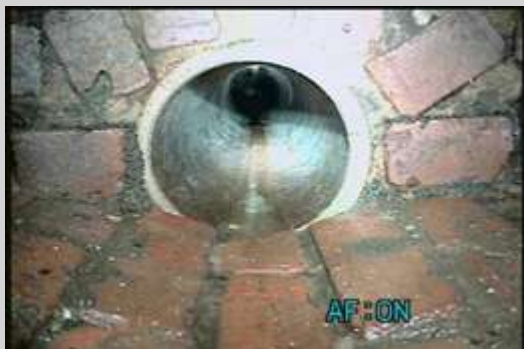
6 O'Clock Inflow

6 in. Circular Gravity Sewer
Pipe In @ 6 O'Clock

Pipe Height: **6** (in.) Rod and Bar (Angled)
Pipe Material: **Clay** ☐ Pipe Lined
Invert Depth: **7.70** (ft.) Flow Characteristics: **Slow**
Deposits: ☒ None ☐ Mud ☐ Sludge ☐ Debris ☐ Grease
Silt Depth: **0** (in.) Deposits Extent:
Infiltration: **None** Pipe Seal Cond: **Sound**
